Serial No.	DRT-A626/1096010-1022	Contact Person	YUYI
------------	-----------------------	----------------	------

Customer		Product	DRT overhaul
Test Date		Maker/model	DRT-A626
		Serial Number	1096010-1022

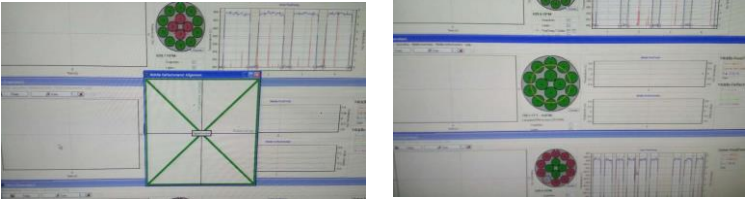
產品外觀檢查 Appearance inspection	產品外觀檢查正常/Pass	
主要功能檢驗 Main function inspection	<p>1.上機測試故障雷達圖打不開，無信號/ On-board test failure radar chart can not be opened, no signal</p>

<p>2.打開DRT進行檢查，RT部分正常(如右圖)-----> RT part is normal (as shown in the right picture)</p>

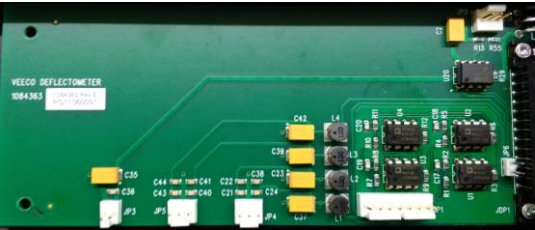
檢驗結果 Test result	<p>DRT主板有毀損,需要更換零件,探頭部分亦有毀損 The DRT motherboard is damaged, parts need to be replaced, and the probe part is also damaged</p>	
維修內容 Repair content	<p>1.更換DRT主電路板內部零件Replace the internal parts of the DRT main circuit board</p>

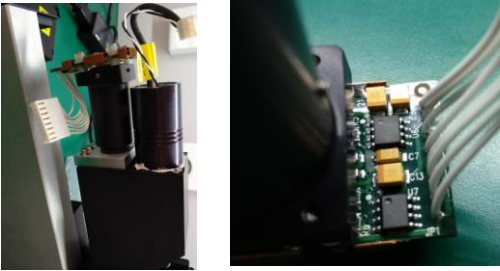
<p>2.探頭部分，發現有晶片損壞，更換(如右圖)-----></p>

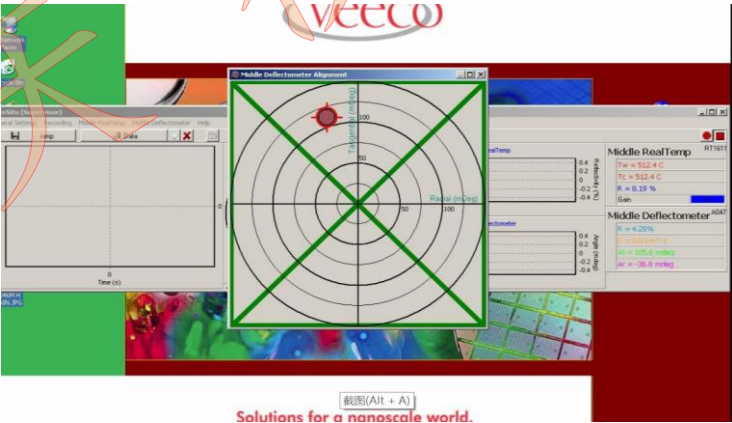
維修後檢驗 Test after Repair	<p>1.組裝上電測試，連接在測試電腦上DRT雷達可以打開，圖像如下</p>

<p>2.裝在機台測試DRT雷達圖可以打開，也有迴曲率</p>
