■ Overhaul Report

Parts MKS Throttle Valve

Model 253B-13964

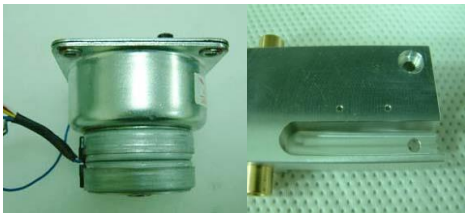
Item	Description	Q'ty	Action
1	2-Phase Stepping Motor	1	Replaced
2	Gear Box	1	Replaced
3	Limit switch	2	Replaced
4	Coupling stick	1	Replaced
5	Bearing	1	Replaced
6	Guiding plate	1	Replaced
7	O-ring	2	Replaced
8	Valve body	1	Cleaned
9	Butterfly plate	1	Cleaned
